# The collapse of table formworks at a construction site - a case study

by Dr Goh Yang Miang, Yee Yew Seng, Er. Liau Wai Kun and Jonathan Tan, Health and Safety Engineering Technical Committee, IES

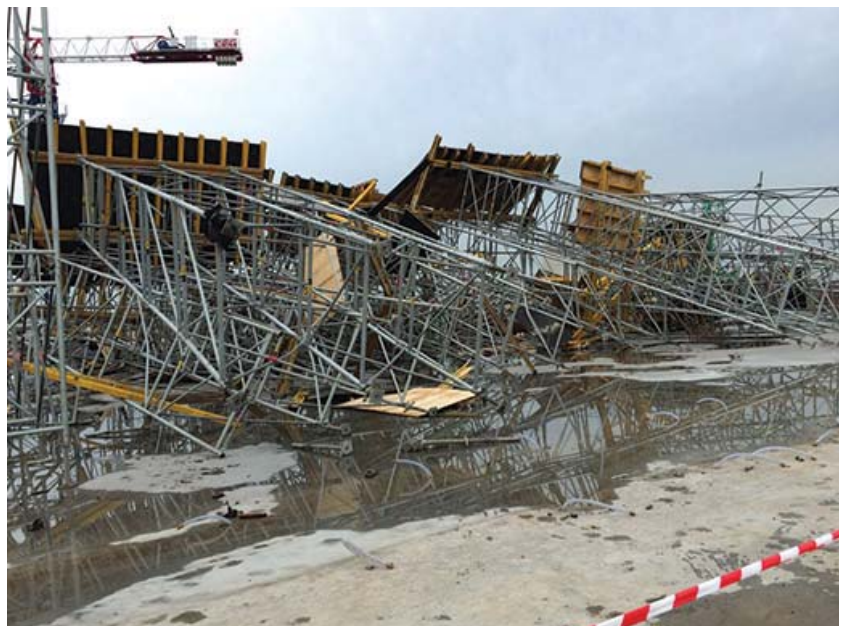
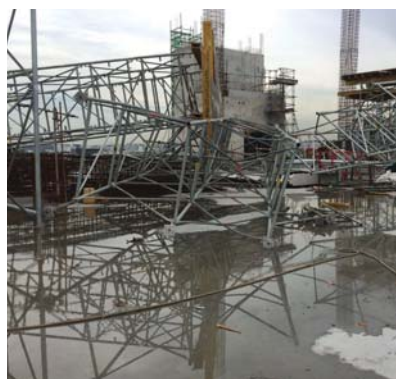
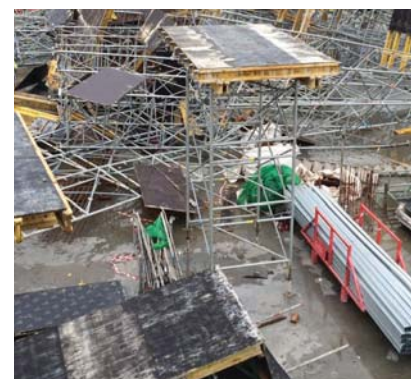
Based on observations from the site visit and the photos provided, the formworks seemed to have collapsed in the same direction. At the same time, the formwork bracings and base plates seemed to have remained largely intact and damage was probably due to the collapse.

The scene of the incident on the morning of 3 August 2016

A rough calculation was conducted by a Professional Engineer (PE), in accordance with CP3: Chapter V: Part 2: 1972, on a pro-bono basis. Using parameters provided by site personnel, it was found that the factor of safety against overturning was less than 0.7. The key overturning moment was due to the wind pressure acting on the free-standing formworks on the windward side. The wind pressure was magnified due to the height of the formwork (10.2 m). Other factors contributing to the overturning include the uplift, wind drag and the lack of stabilising moments. Once the formworks on the windward side collapsed, they triggered a domino effect, leading to the collapse of the 24 formworks.

- Reducing the exposure of free-standing table formwork to effects of wind, by dismantling them as part of the lifting process and as soon as possible.
- Weighing down vertical footings of formwork, by means of anchorage or temporary counterweights.
- Attaching outriggers to vertical footing of formwork.
- Providing for diagonal and horizontal bracing, to connect the table formworks to form a more rigid integrated structure.

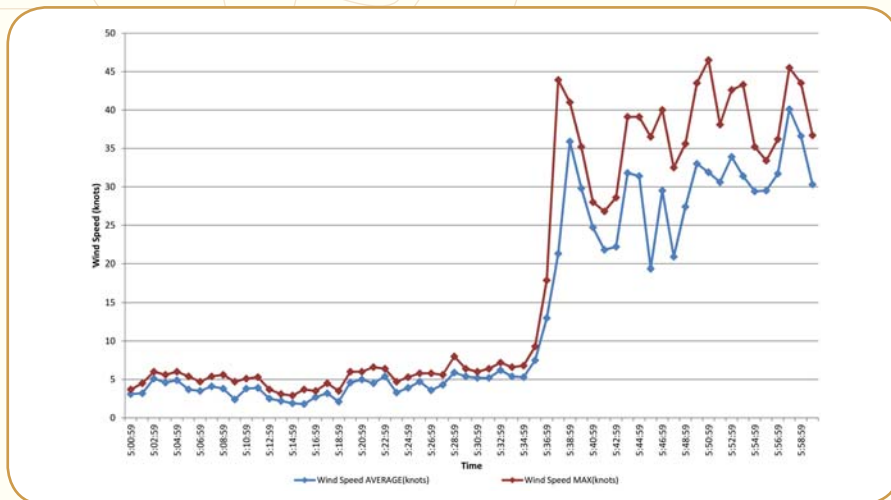
Wind speeds between 5 am and 6 am

cause of the collapse. The meteorological report showed that the maximum wind speed near the worksite, between 5.50 am and 6 am (estimated time of the collapse), was 46.5 knots (23.9 m/s) and the average wind speed was 40.1 knots (20.6 m/s). This is significantly higher than the average monthly surface wind speed of 2.5 m/s in August 2016 (<http://www.weather.gov.sg/climate-climate-of-singapore/>).

As can be observed from the time series plot of average and maximum wind speed, the wind speed rose suddenly at about 5.35 am.
