Incident Investigation Improved by Applying the Event Causation Technique : A Case Study

Safety and Resilience Research Unit (SaRRU), Department of Building (DOB), School of Design and Environment (SDE), National University of Singapore (NUS)

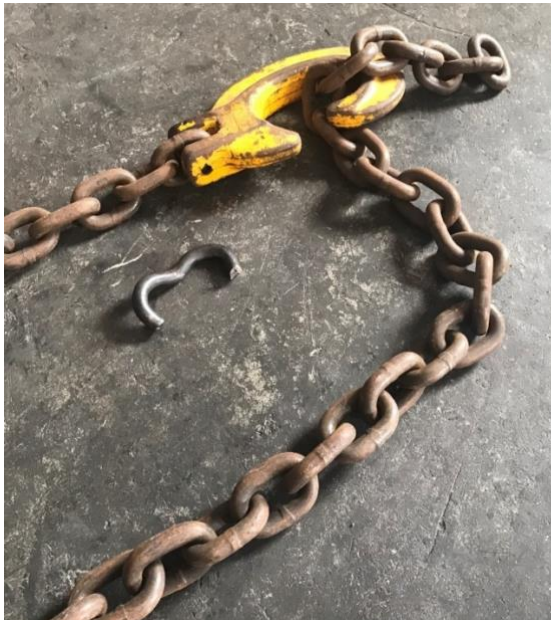
1. On 9th September 2019, a group of workers were deployed to discharge steel cargo from a vessel.
2. The team used two 12-tonne chain slings (1.5 m each) and two 8-tonne chain slings (9 m each) with Clevis hook to discharge the H-beam steel cargo.
3. At 2030hr, one of the 8-tonne lifting gear broke at the link, causing the cargo to drop 1 – 2 feet.
4. No injury was reported and work operations were stopped immediately.
5. The investigation report stated fatigue of the lifting gear as a contributory factor.

It is noted that the company requested the same AE who inspected the LG prior to the incident to re-inspect the LG after the incident. To avoid any potential conflict of interest, it is a good practice to appoint an independent AE to re-inspect the LG after an incident. Nevertheless, the remaining chains in the chain sling that failed (see Figure 1) were inspected and tested by an independent engineering company. However, no failure analysis was conducted to confirm the cause of the failure.

Figure 1 The broken link of the 8-tonne lifting gear
